-- LAKE SHIRLEY DAM --
EMERGENCY ACTION PLAN

Dam Name: Lake Shirley Dam
State Dam ID#: 4-9-270-3
NID ID#: MA00455
Owner: Town of Lunenburg
Owner Type: Municipality
Town: Lunenburg, MA
Consultant: Stantec Consulting Services, Inc.
Date of Issue: August 4, 2023 (Updated)

**EMERGENCY ACTION PLAN
LAKE SHIRLEY DAM**

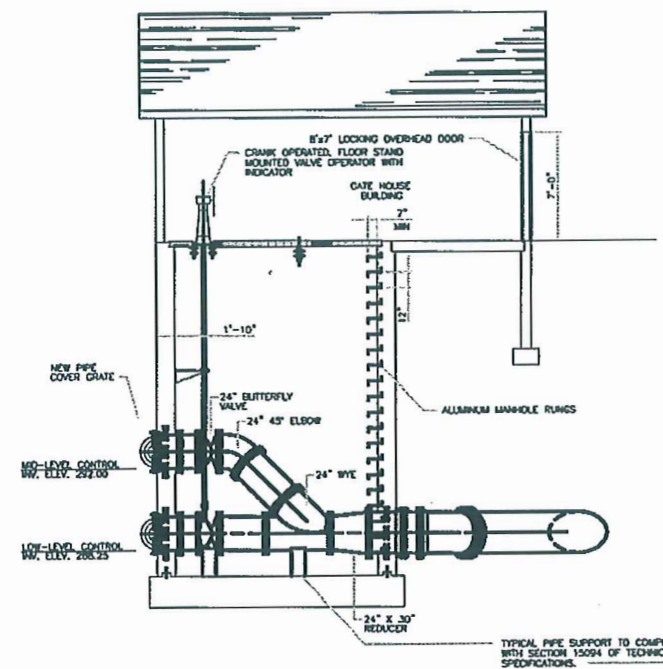
GATE HOUSE SIDE ELEVATION

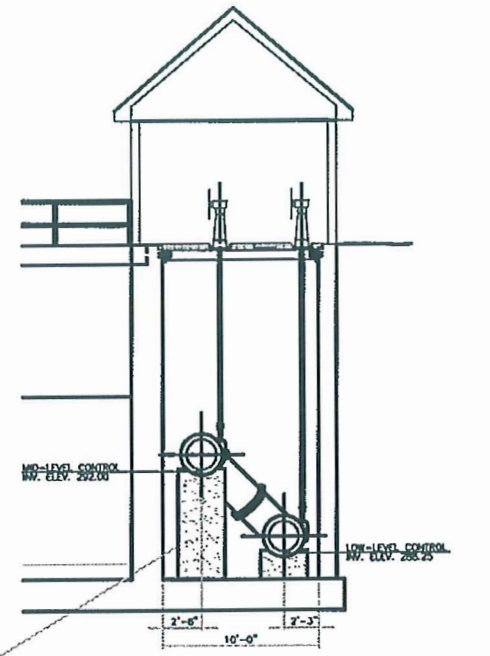
GATE HOUSE FRONT ELEVATION

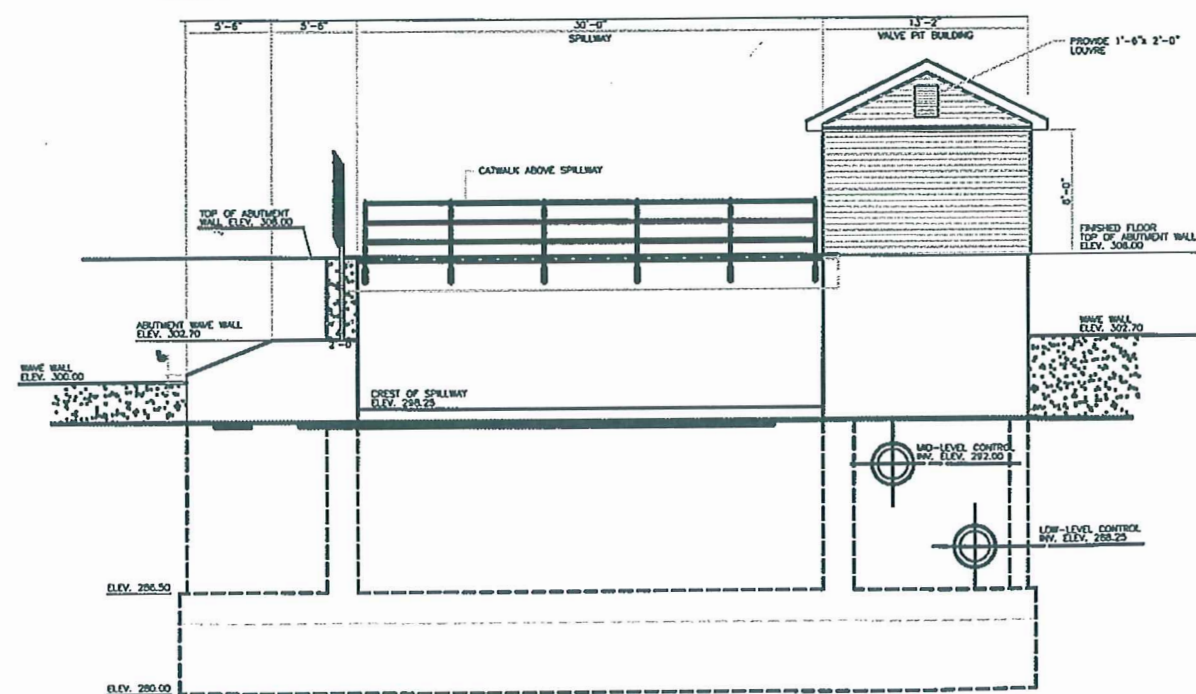
GATE HOUSE SECTION

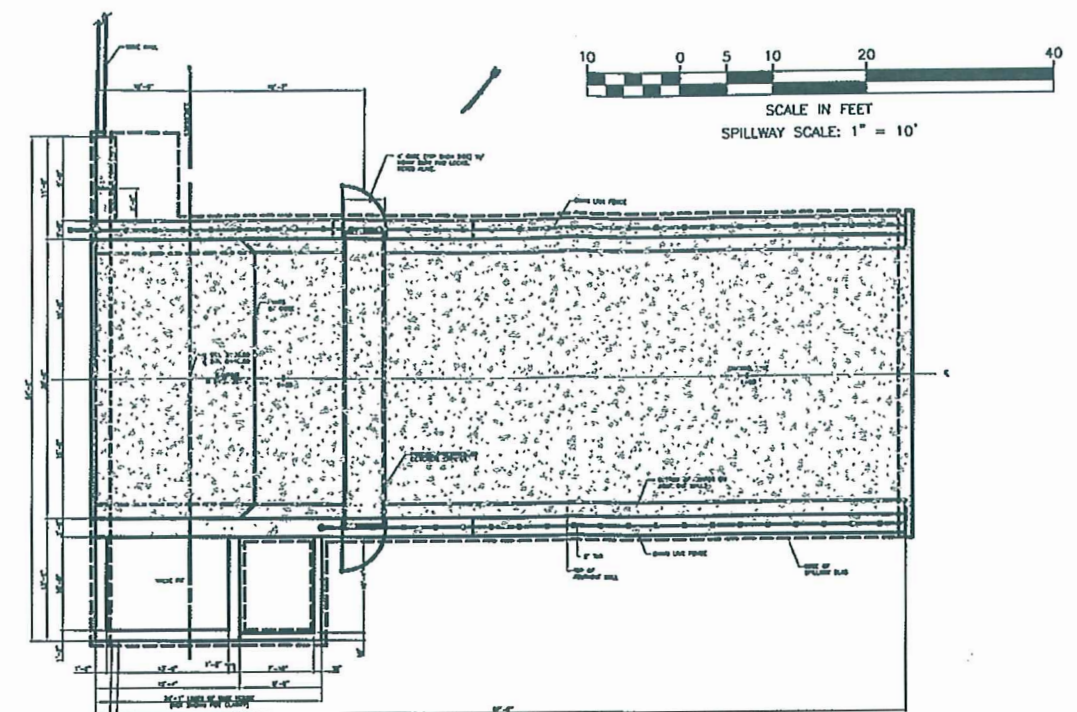
SPILLWAY PLAN

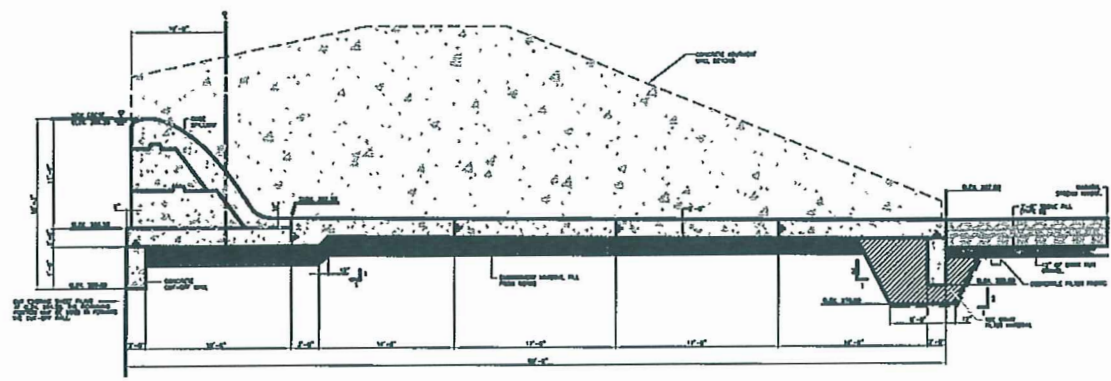
SPILLWAY PROFILE

NOTES:
 1. NOTE THIS DRAWING IS FOR REPRESENTATIONAL PURPOSES ONLY. IT DOES NOT DEPICT ACTUAL AS-BUILT CONDITIONS OF REHABILITATION CONSTRUCTION PERFORMED AFTER 1995.

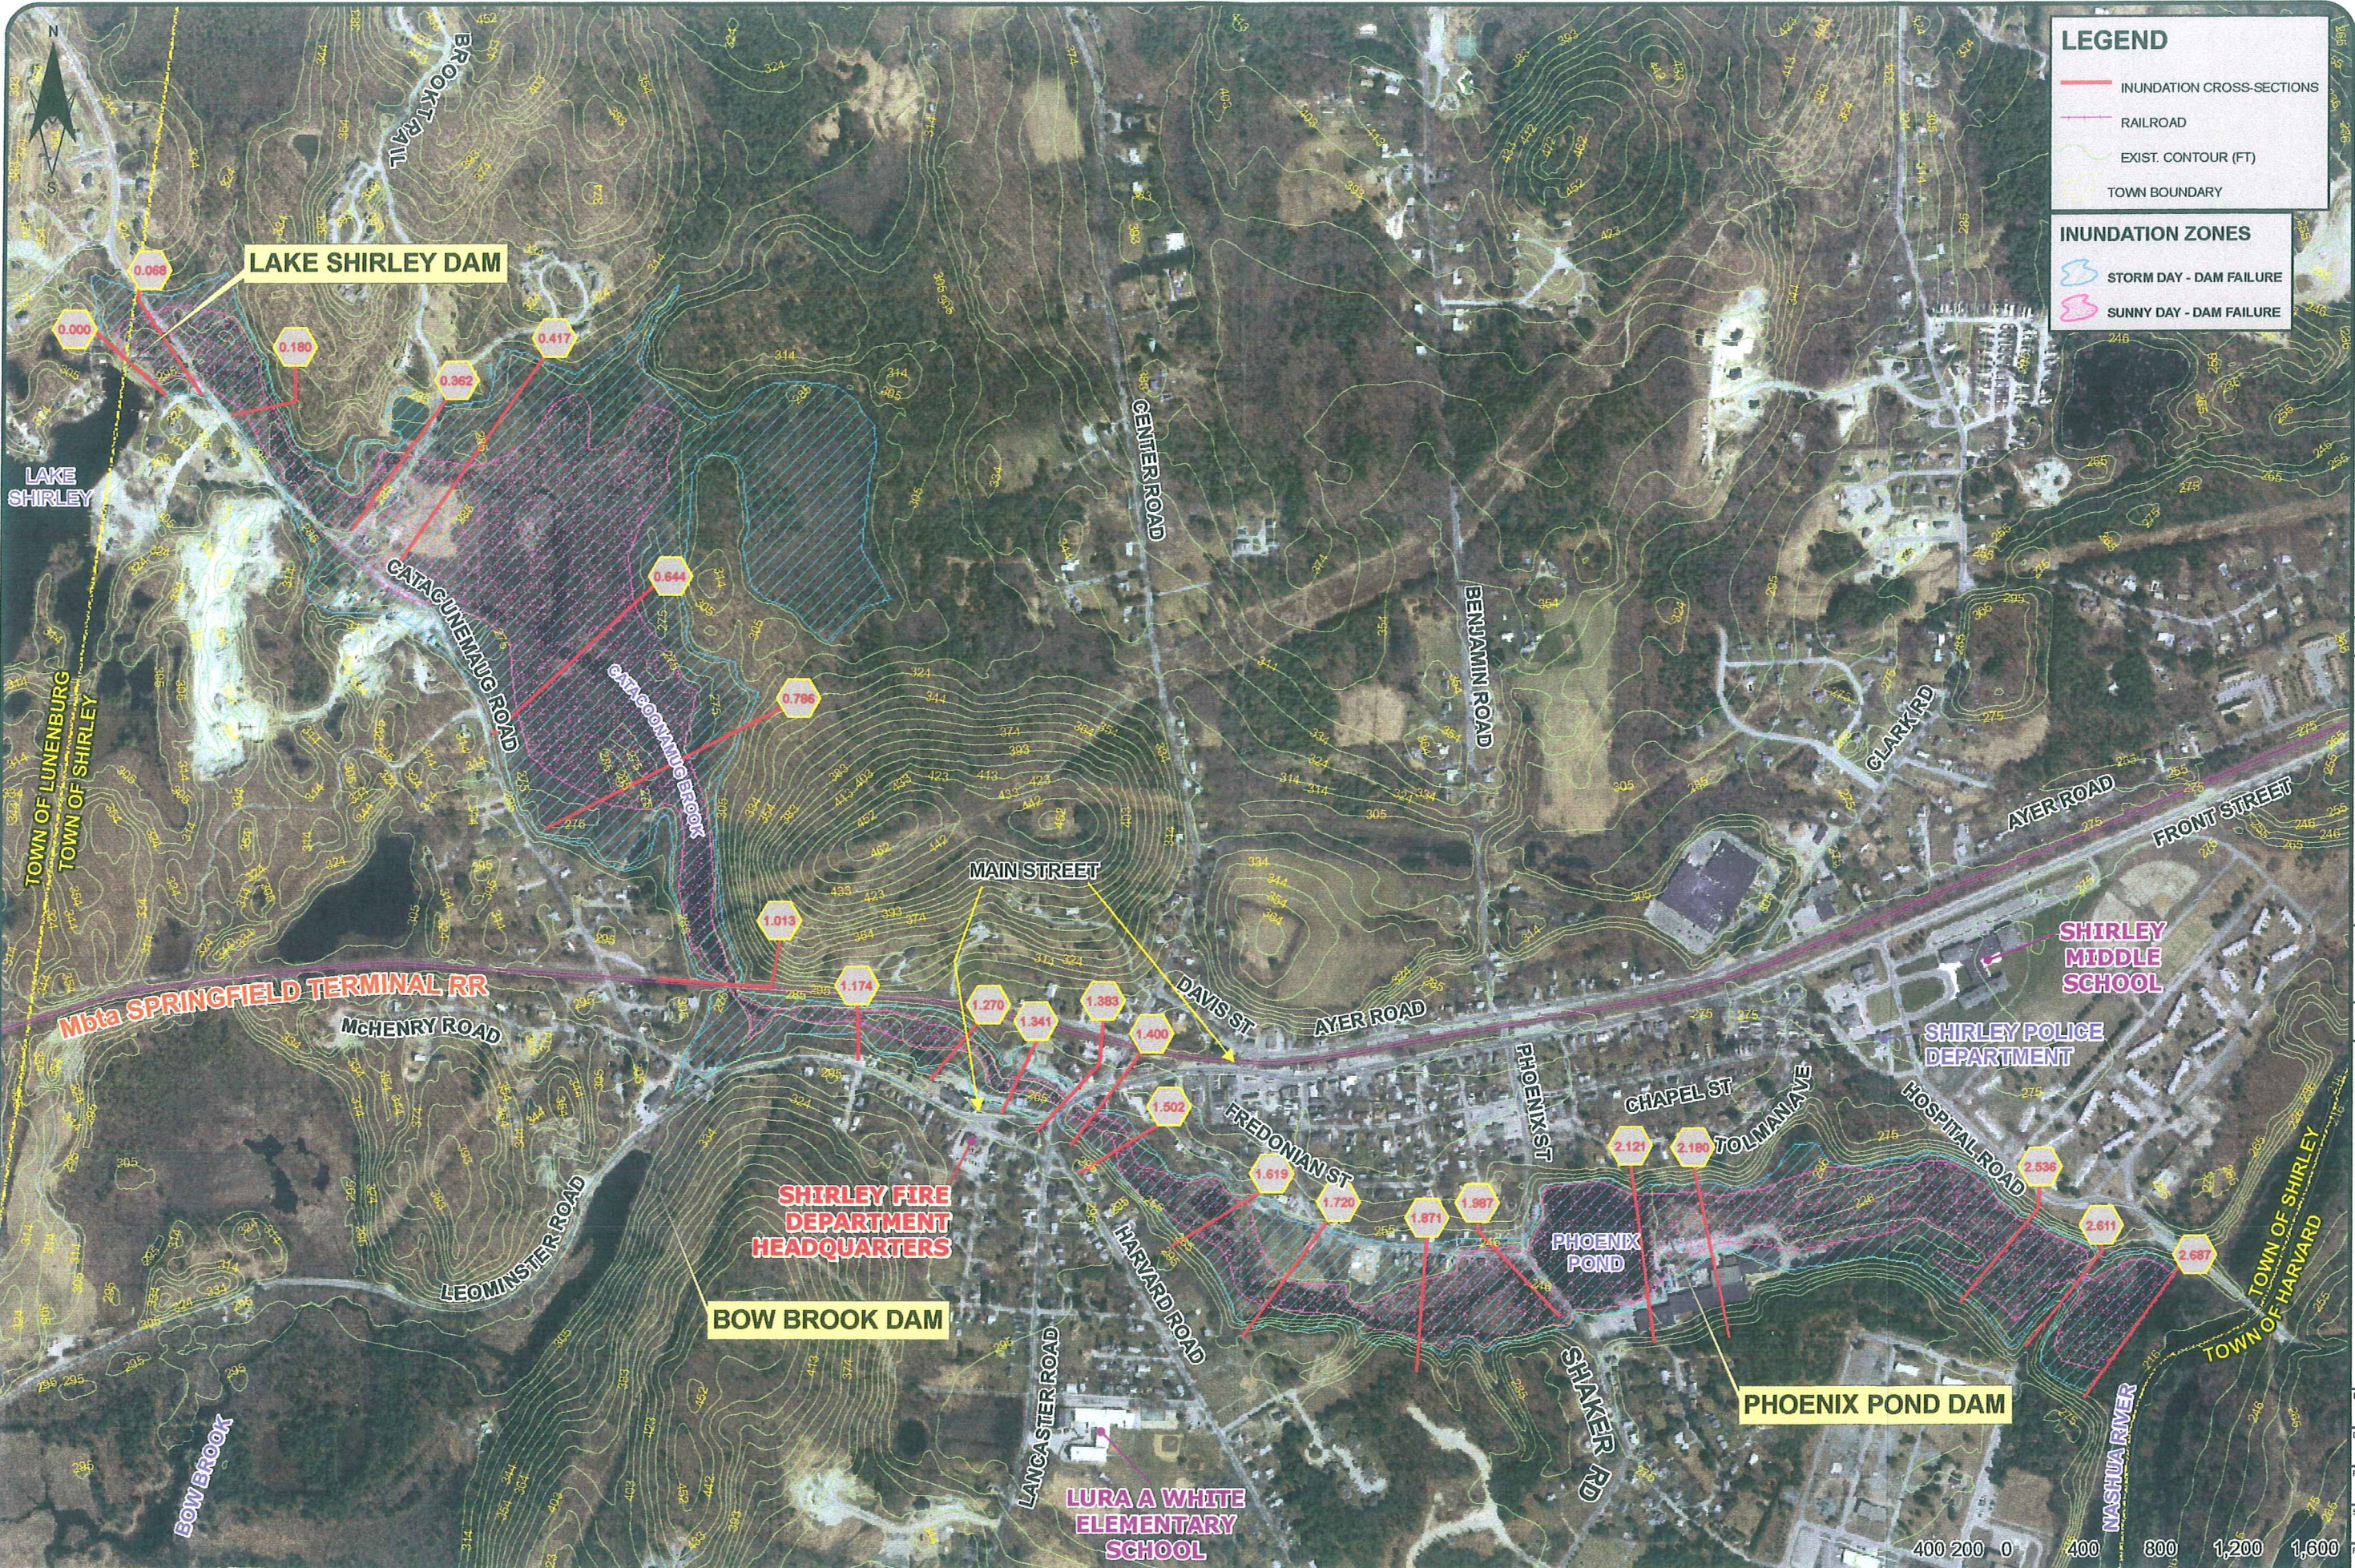
- INUNDATION CROSS-SECTIONS
- RAILROAD
- EXIST. CONTOUR (FT)
- TOWN BOUNDARY

Due to the high degree on variability in the type, size, and timing associated with dam breaches and flooding and the variability of the weather, the depth and associated aerial extent of flooding may increase or decrease depending on the exact circumstances of a particular dam breach or flooding scenario. Also the computer modeling of the dam-break flood wave down the Catacoonamug Brook valley assumes that the valley and structures such as bridges and culverts do not become partially or fully blocked with debris. If a structure becomes blocked with debris, then the peak water surface behind the blockage could increase to flood depths higher than estimated.

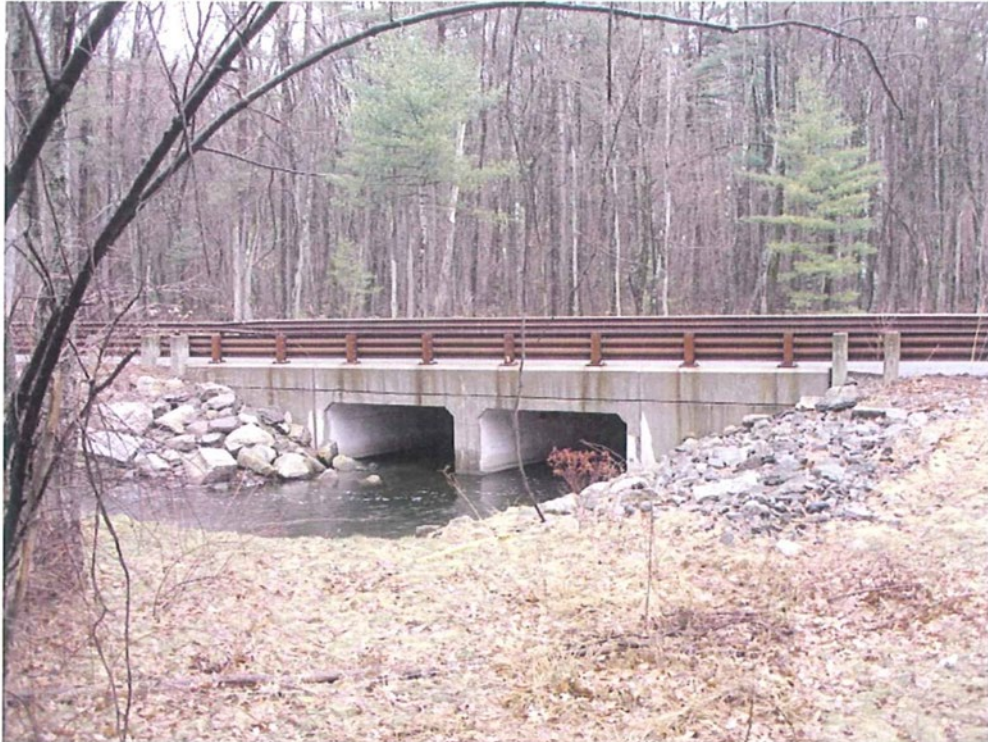
Photograph No.1: Catacunemaug Road (MM 0.682) is overtopped by approximately 7-feet during the hypothetical storm-day dam failure

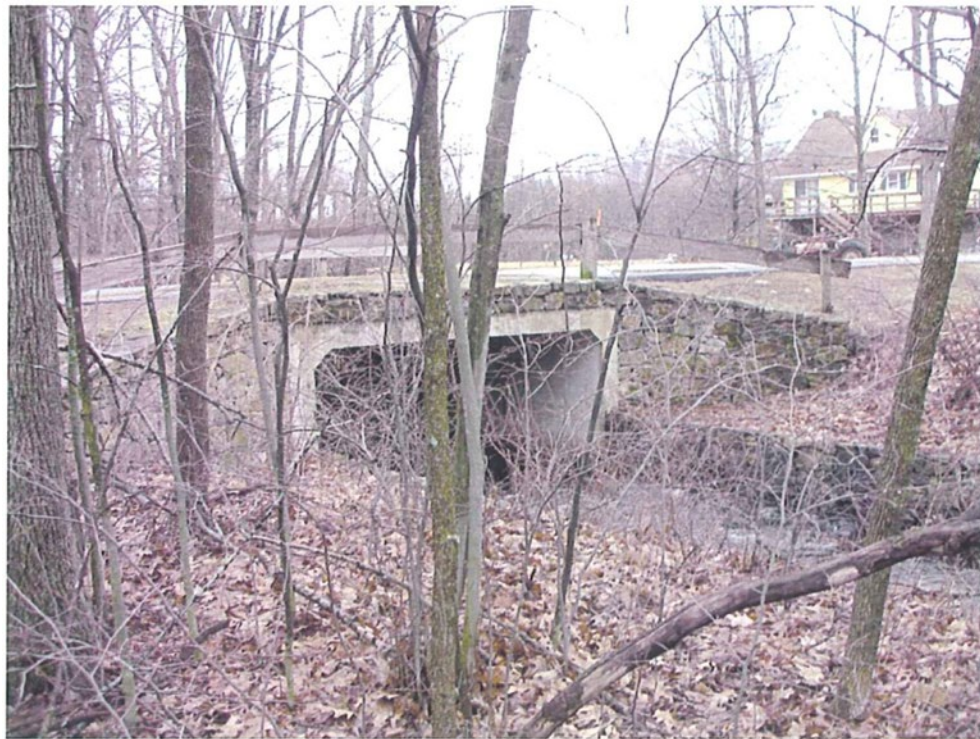
Photograph No.2: Brook Trail Road (MM 0362) is overtopped by approximately 6-feet during the hypothetical storm-day dam failure

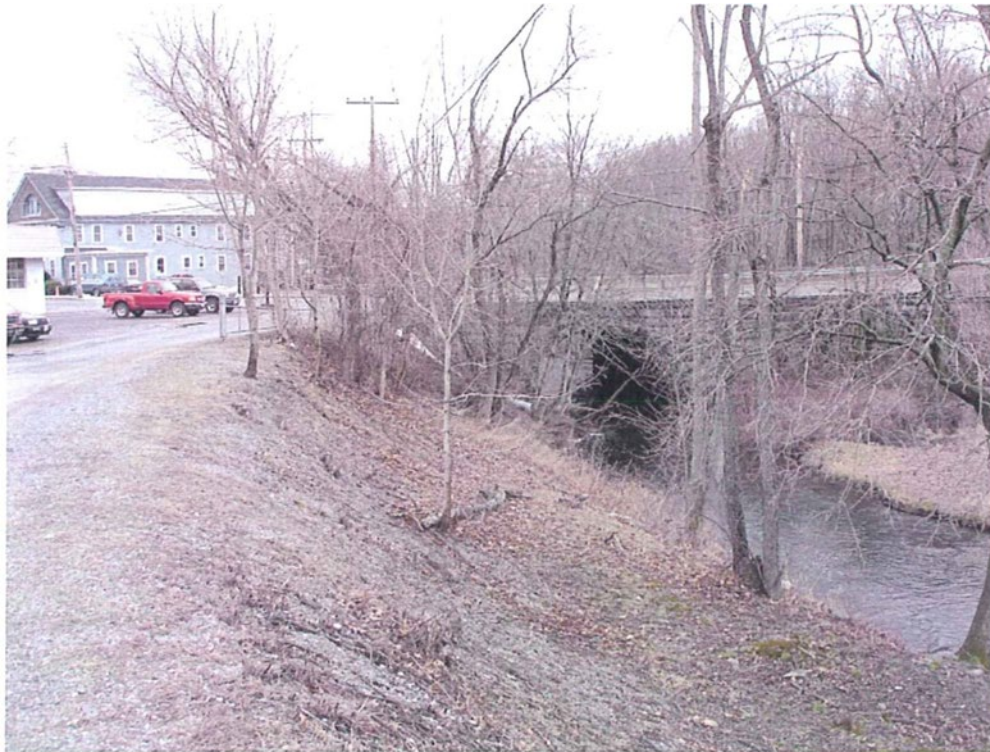
Photograph No.4: Leominster Road (MM 1383) is overtopped by approximately 5-foot during the hypothetical storm-day dam failure.

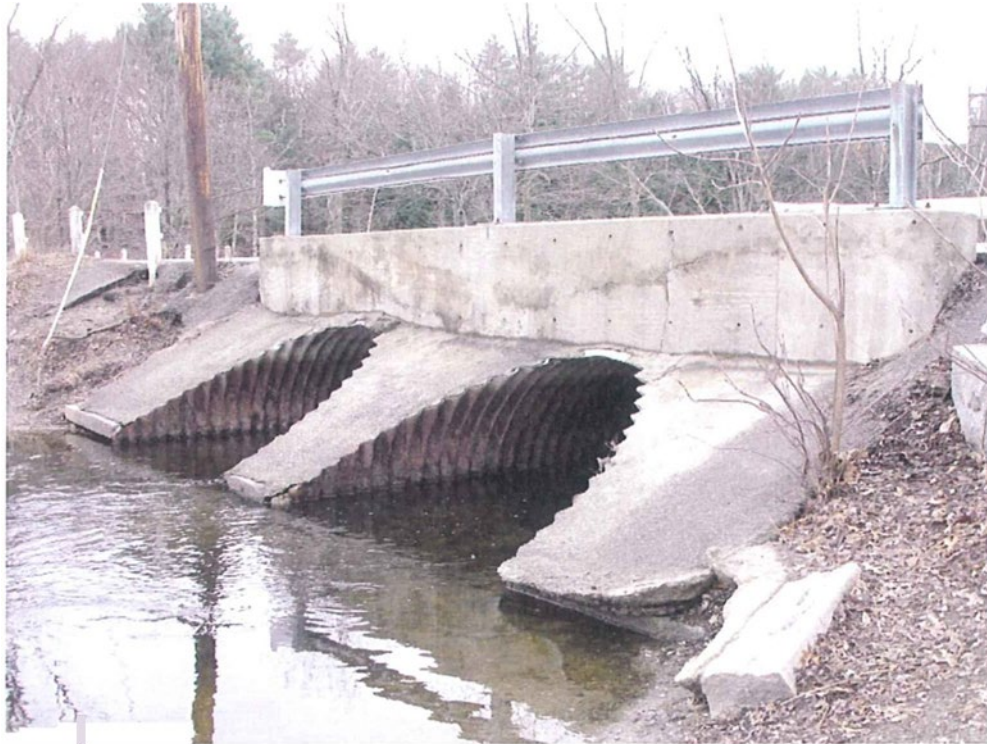
Photograph No. 5: Shaker Road (MM 1.987) is overtopped by approximately 6-feet during the hypothetical storm-day dam failure.

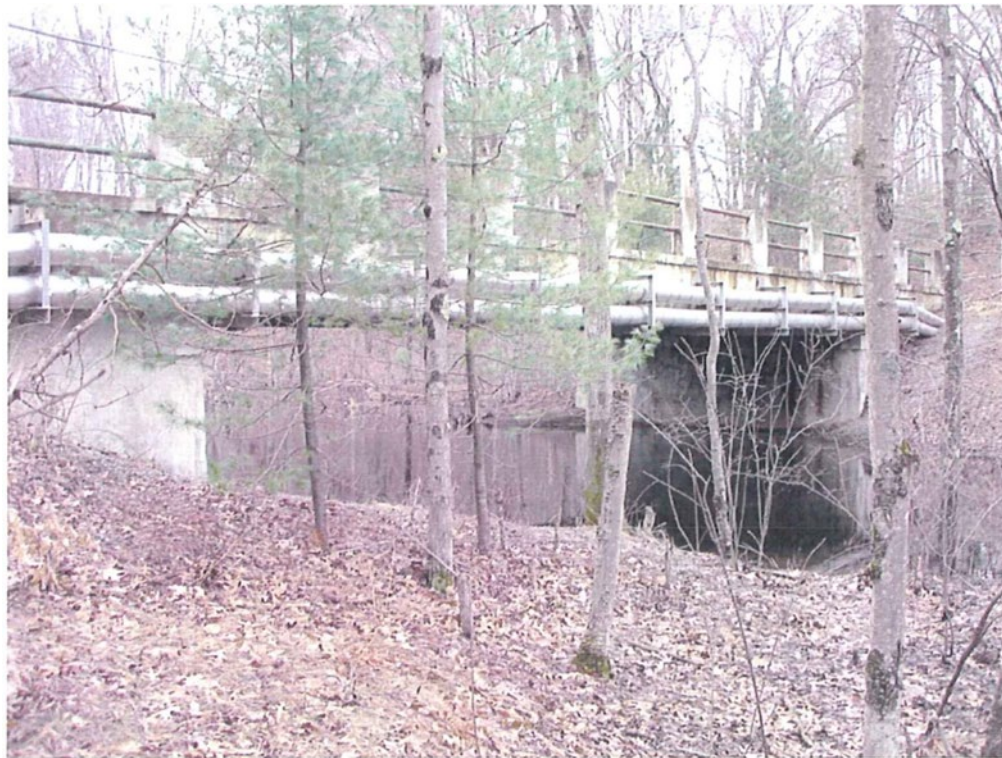
Photograph No. 6: Lowell Road (MM 2.611) is overtopped by approximately 1-foot during the hypothetical storm-day dam failure
